EU EDF 8/9 – SOPAC Project Report 53
Reducing Vulnerability of Pacific ACP States

TECHNICAL REPORT ANALYSIS OF COASTAL CHANGE AND EROSION – TEBUNGINAKO VILLAGE, ABAIANG, KIRIBATI

March 2006

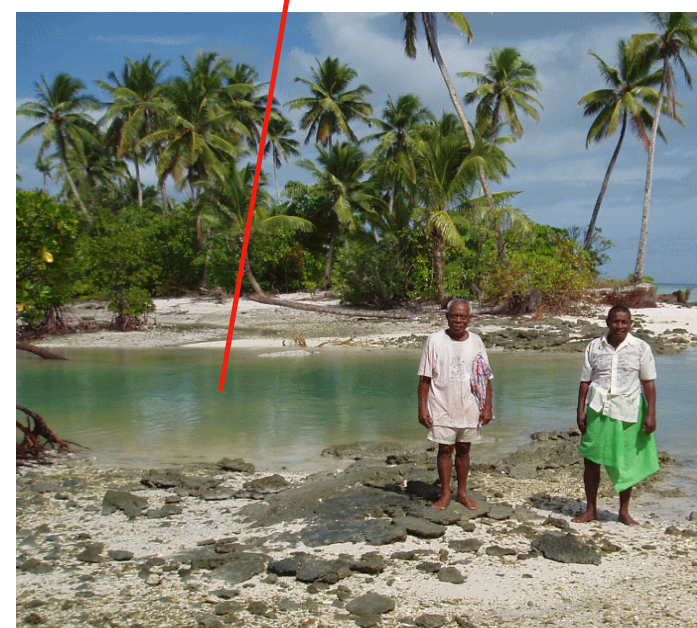
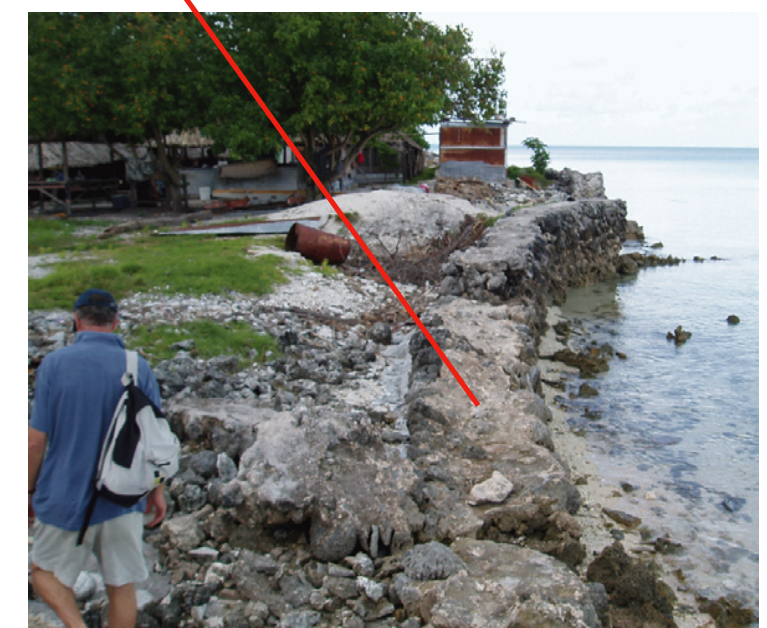
The 2004 satellite image close up of the Tebunginako Village area and a summary of the issues presently faced by the village. Seawall failure, erosion of the sand bank and subsequent break through of lagoon waters into a formerly freshwater pond. Also, nuisance seawater flooding on the village boundary.

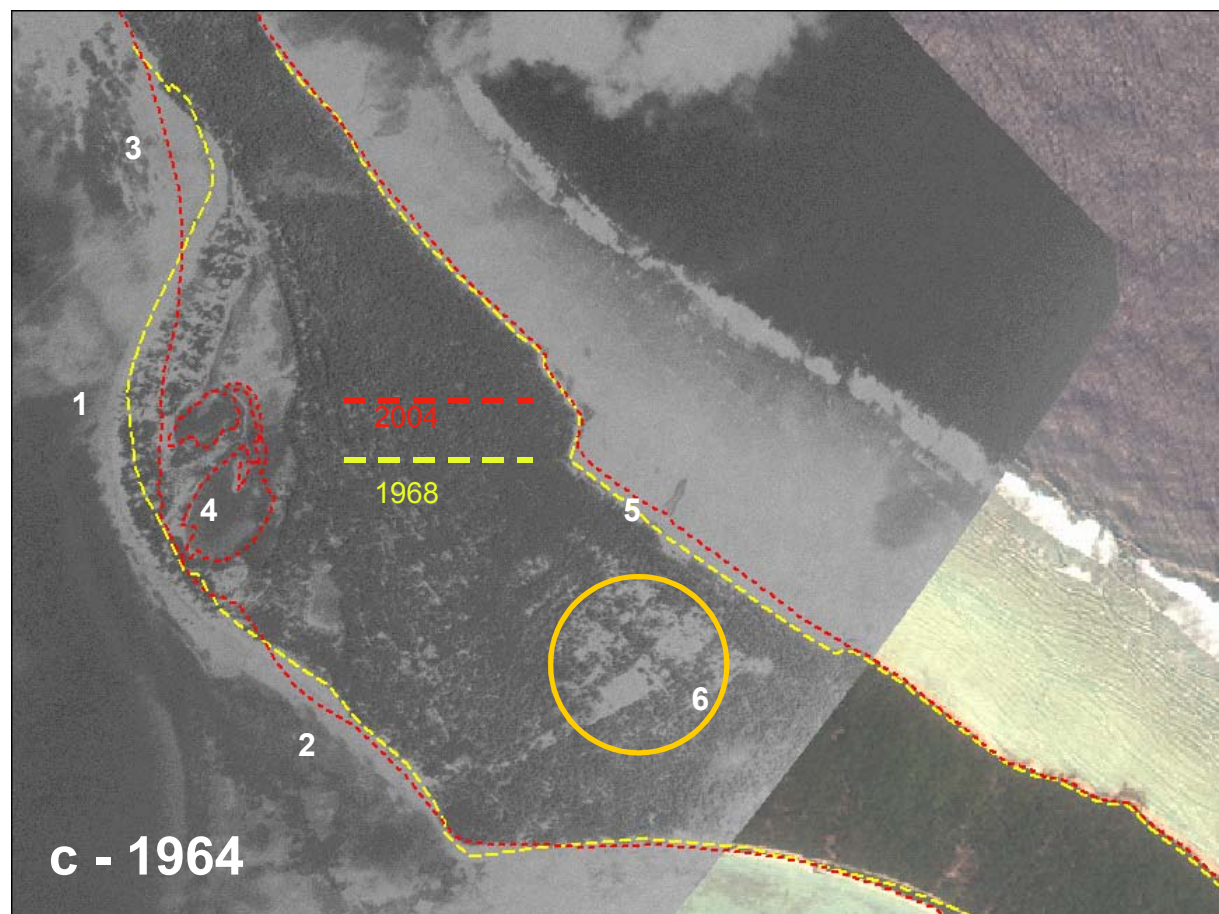
Historical coastline changes (multi-temporal comparisons)

These figures show a comparison of the Tebunginako Village area in 2004 (a), 1968 (b) and 1964 (c). The superimposed shorelines shows the large degree of shoreline change particularly on the lagoon coast (note all images are of identical scale and orientation and the black and white historical aerial photo boundaries can be seen where they overlay the base satellite colour image).

In 2004 (a) the position of the 1964 (red) and 1968 (yellow) coastlines show that approximately 2.73 Ha (6.7 acres) of land has been lost in area (1). However about 2.56 Ha (6.3 acres) of land has also accreted (built up) in areas 2 and 3. This shows that whilst there has been erosion at some locations (e.g. 1) the sediments are being redeposited in other locations. At location 3 the shoreline has accreted by nearly 100 m since 1964, overall there has only been a net loss of 0.165 Ha (0.41 acres) of land over the last 40 years.

Of particular concern to the village community however, has been the recent break through of lagoon waters into the freshwater ponds south of the village (4). In this area the shoreline has eroded about 50 m since 1964.

The historical aerial photographs (b and c) show some additional important information which gave clues as to what processes have been at work in this area during the last 100 years or so. Location 5 shows that a section (about 650 m long) of the ocean-side coast has also prograded (moved out) by some 20 m since the 1960's. The area in 6 (orange circle) shows a persistent feature in the vegetation of this area. Note the poor / sparse vegetation (whitish area) and the persistent curving boundary to the south of this feature. This is thought to be a prograding shoreline of the now in-filled channel and similar line features (running approximately parallel) can be detected over much of Tebunginako.

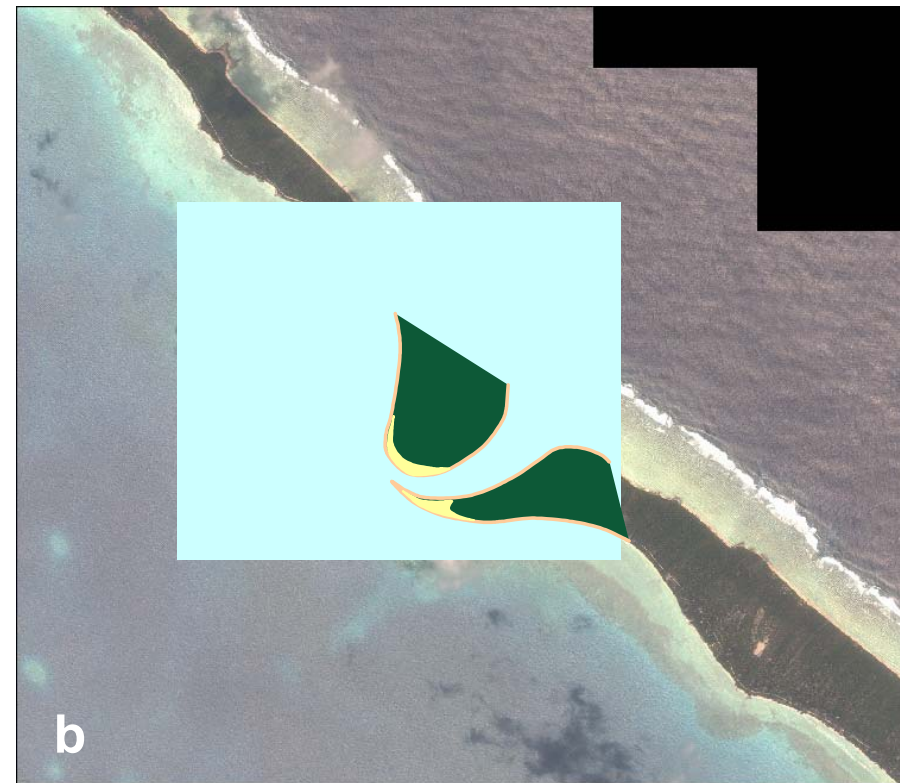
(b) Over time the channel fills with sand and eventually becomes narrower and shallower. The persistent northern sand transport pattern not only supplies this sand from the ocean reef through the passage but on the lagoon side it pushes a sand spit extending to the north.

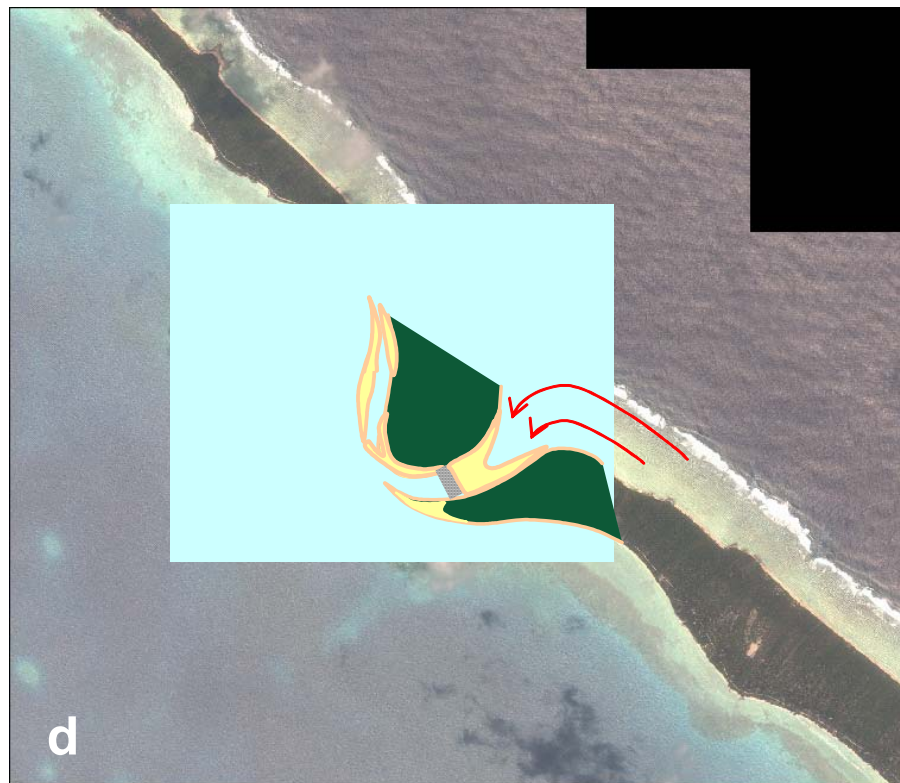
(d) At some time, about 70 to 100 years ago, villagers built a causeway across this channel (this area is still known as “*Terawabono*” – “the blocked channel”). This stopped the supply of sand moving to the lagoon side.

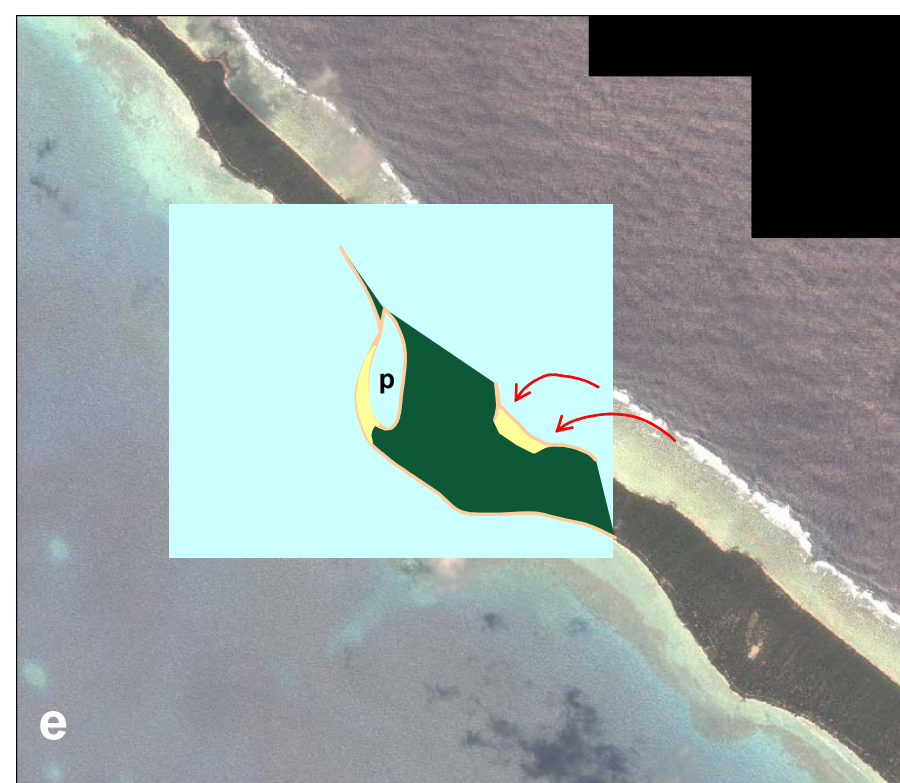
(e) With sand supply blocked the channel on the ocean side quickly in-filled (red arrows). On the lagoon side the unstable sandy spit moves and changes shape since the supply of sand from the ocean has stopped. Low areas which were once part of the lagoon / channel are isolated from the sea and over time become freshwater ponds (p).

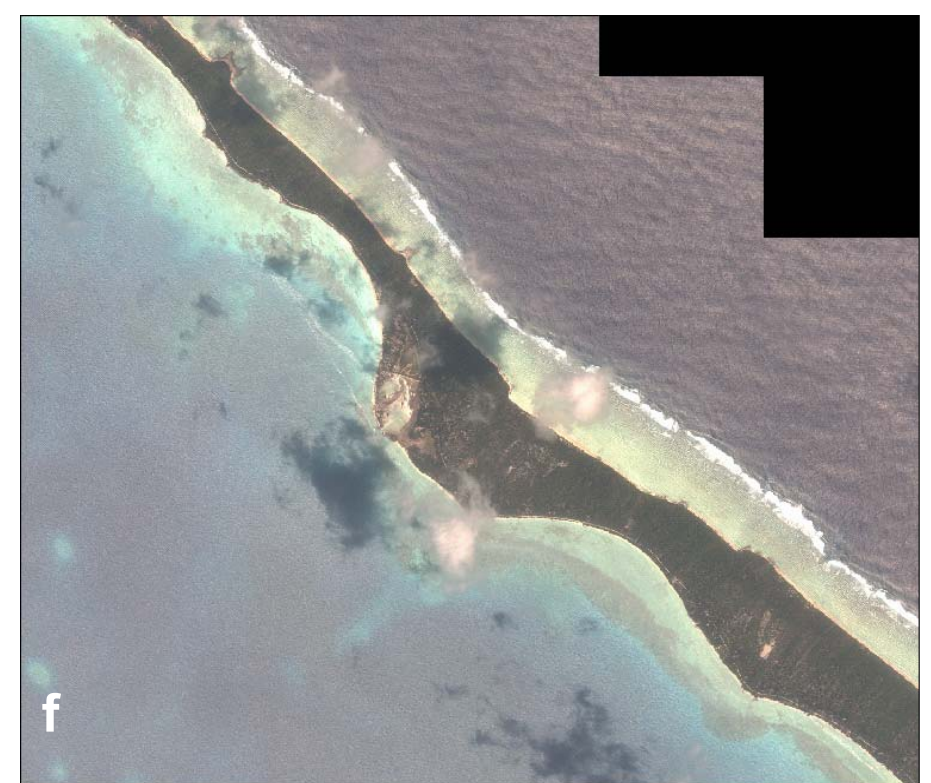
(f) Today, many people now live on this new land; however, the Tebunginako coastline is still moving and is unstable. The sand bank between the freshwater ponds and the lagoon has eroded to a thin strip and lagoon waves have now broken through, flooding settled areas with seawater.
