NEDIES PROJECT

# Lessons Learnt from Landslide Disasters in Europe

Edited by  
Javier Hervás

EUR 20558 EN

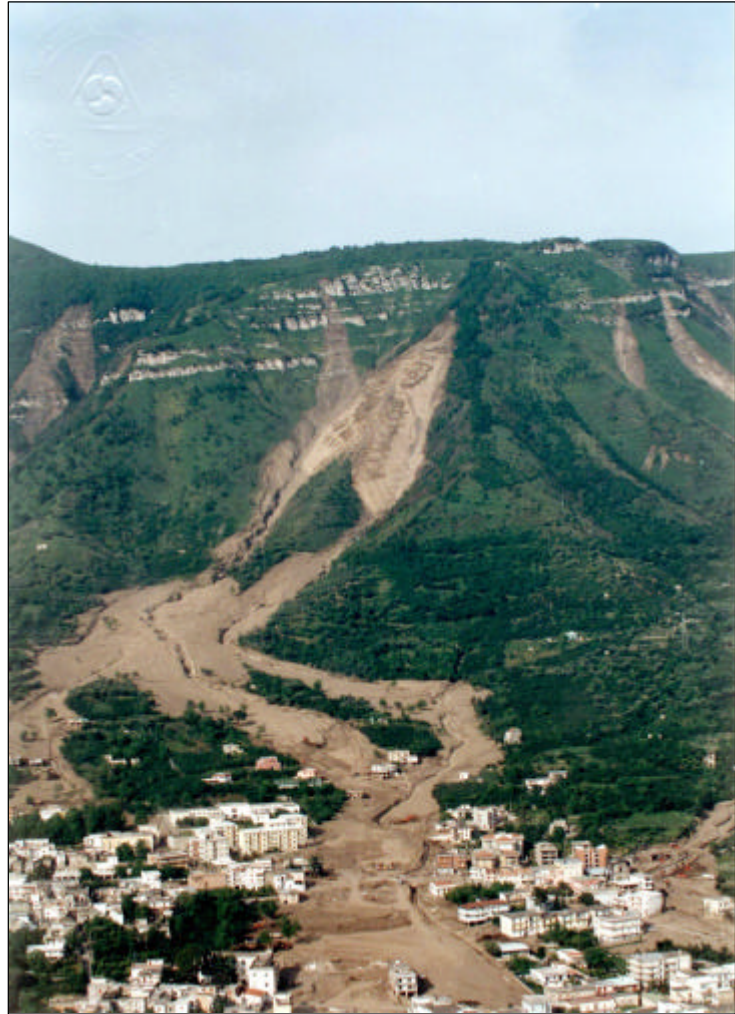
**Figure 2.3** Area impacted by the mudflow in Sarno (Centro Documentazione, VV.F. Napoli).

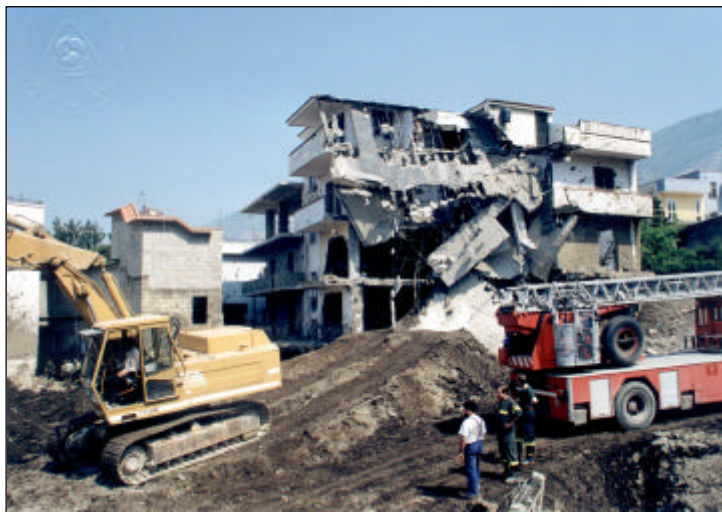
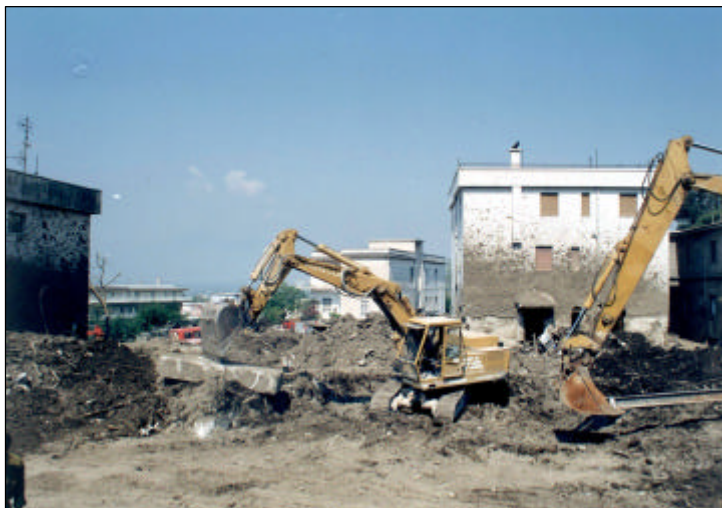
**Figure 2.4** Excavators in action during the response phase in Sarno. In the lower picture, the grey bend on the white building, which marks the maximum level reached by the mudflow can be observed (Centro Documentazione, VV.F. Napoli).

The event caused heavy damages to public and private buildings (Dipartimento della Protezione Civile, 2001; Fig. 2.4), as shown in Table 2.3, and infrastructures; furthermore, they visibly changed the local landscape.

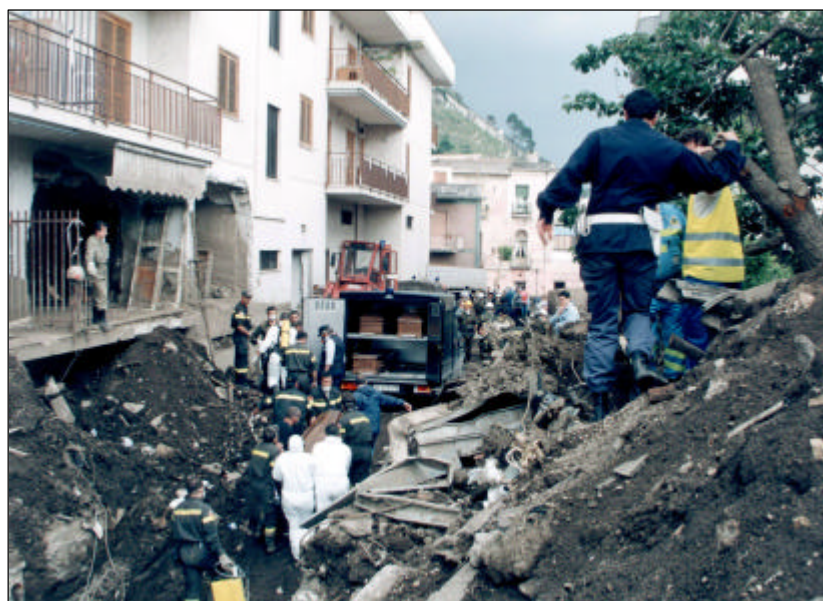
**Figure 2.5** Operational bodies at work in Sarno (Centro Documentazione, VV.F. Napoli)

48 hours after the beginning of the event, the Ce.Si. reported 2,970 men and 192 vehicles (cars, buses, water-scooping machines, excavators, dog units, ambulances, helicopters and breakdown lorries) operating in that area. The highest number was registered on 22 May: 5,043 men and 1,470 means, as listed in Table 2.5 (Dipartimento della Protezione Civile, 1998; Fig. 2.5).

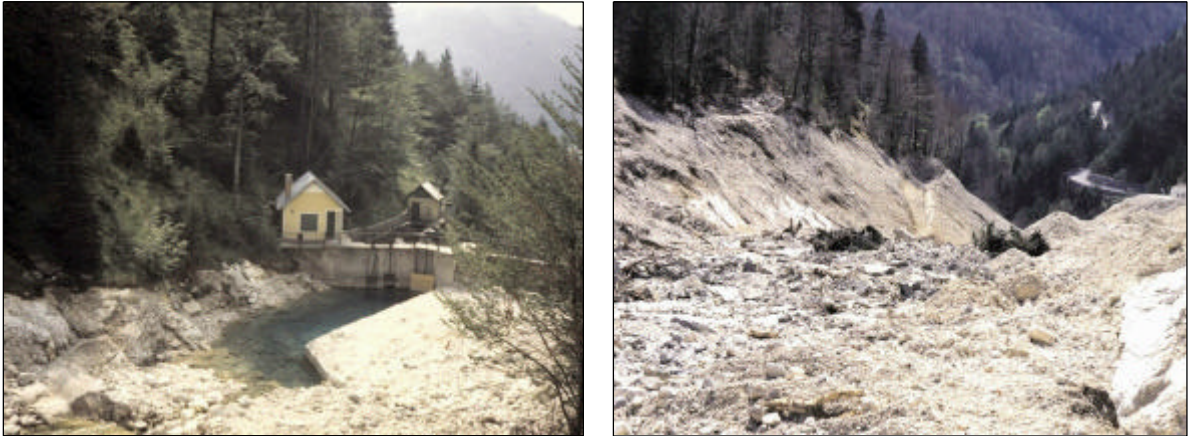
**Figure 3.2** Mangart hydropower plant before and after its destruction by the landslide of 15 November 2000 (photograph: archives of the PGD Log pod Mangartom)

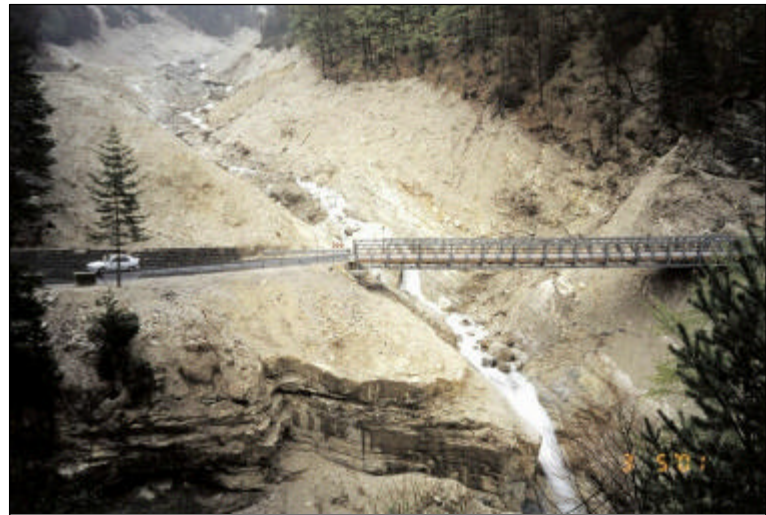
**Figure 3.3** New bridge over the Mangartski potok torrent on the road to Predil (Photograph by M. Slokar)

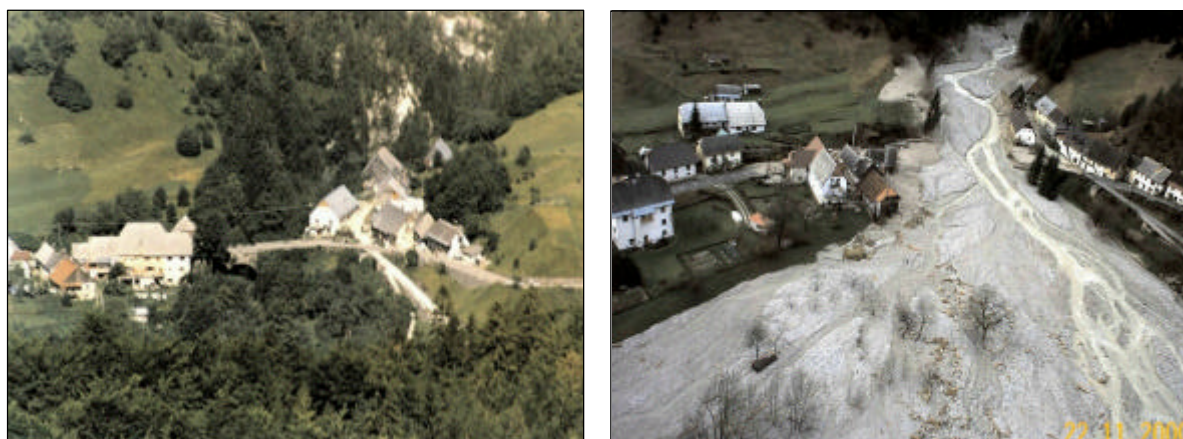
**Figure 3.5** The village of Log pod Mangartom before and after the debris flow (photographs by Ž. Mlekuž and A. Horvat)

6 houses and 7 farm buildings were destroyed. Another 11 houses and 1 farm building in the village were damaged.

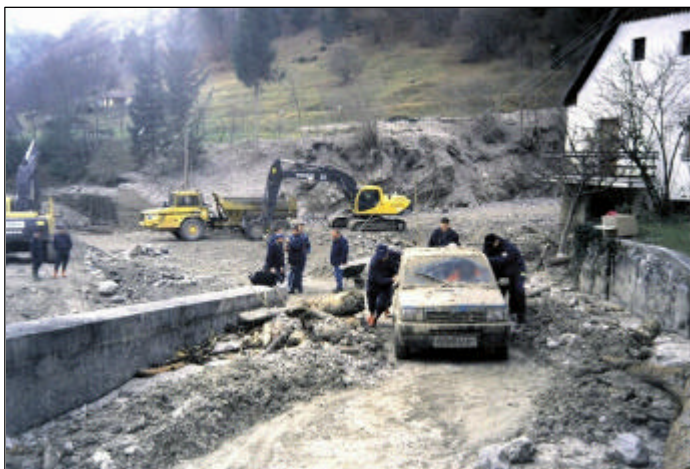
**Figure 3.6** First intervention measures (Photograph: archives of the PGD Bovec)

Because of the complex situation a team of experts from various fields was formed on 18 November. The team was split in two groups: one with the experts in engineering geology (Majes *et al.*, 2000) and the other in hydrotechnics and torrent control (Horvat *et al.*, 2000). On 25 November 2000 they examined the situation and proposed temporary measures for the affected area. The evacuated inhabitants should stay out of the village of Log pod Mangartom until the following spring. The Municipal protection unit, the local fire brigade and some inhabitants from the village also took care of the animals and the property in the village (Fig. 3.6 and 3.7).

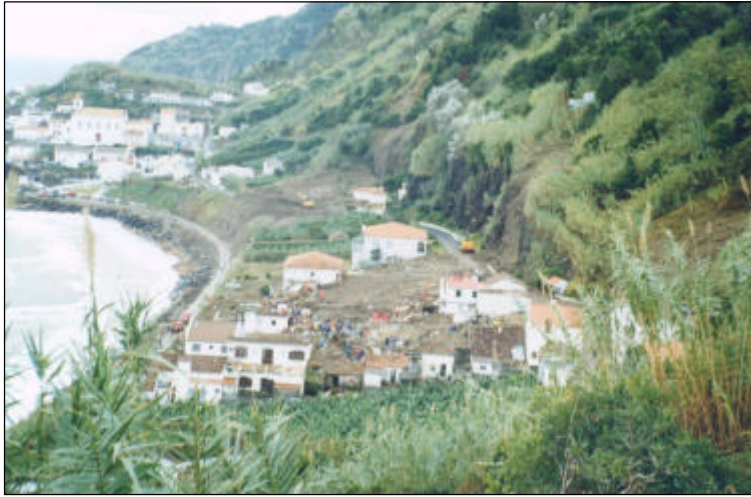
**Figure 4.2** Village of Ribeira Quente after the landslides

On 31 October 1997 near 1000 landslides occurred at S. Miguel Island, in the Azores archipelago, a few of them killing 29 people living in the village of Ribeira Quente (Fig. 4.1). In addition, 7 people were injured and 69 remained homeless. The Povoação and Nordeste counties were particularly affected during this event (Gaspar *et al.*, 1997; Gaspar and Guest, 1998). Several houses and bridges were partially or totally destroyed; communications, transportation and the energy supply system were disrupted and areas of fertile land were covered by mud (Fig. 4.2, 4.3, 4.4 and 4.5). Ribeira Quente remained isolated for more than 12 hours. In total, the material losses amounted to €21 million.

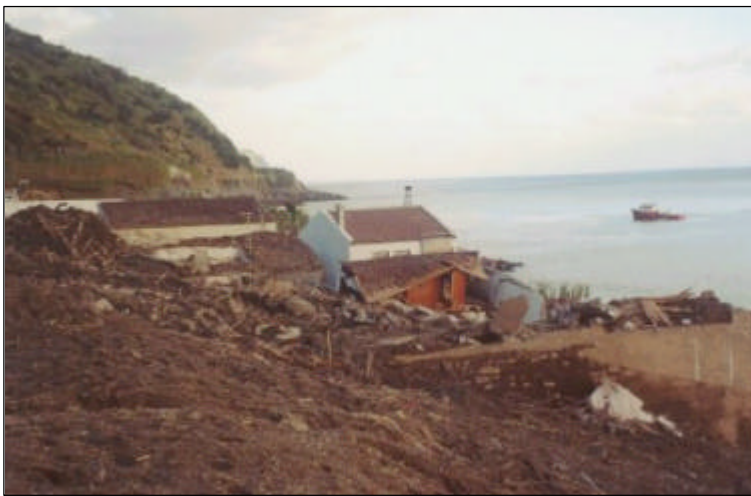
**Figure 4.3** Houses destroyed in Ribeira Quente, and mud and debris covering the village

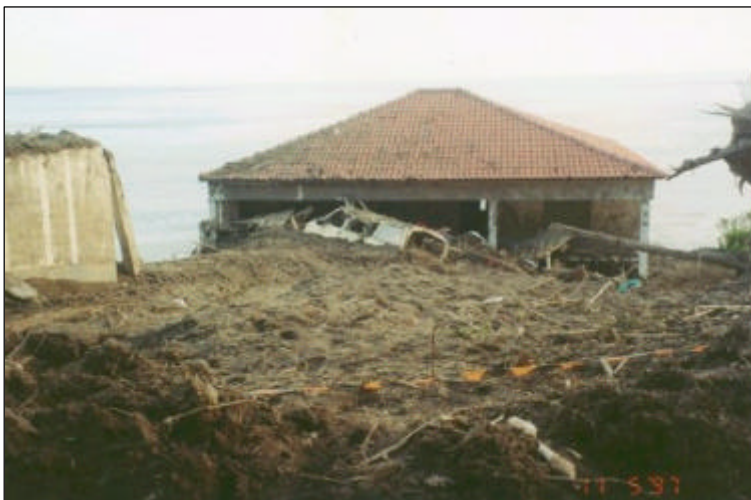
**Figure 4.4** House and property destroyed by mudflows in Ribeira Quente

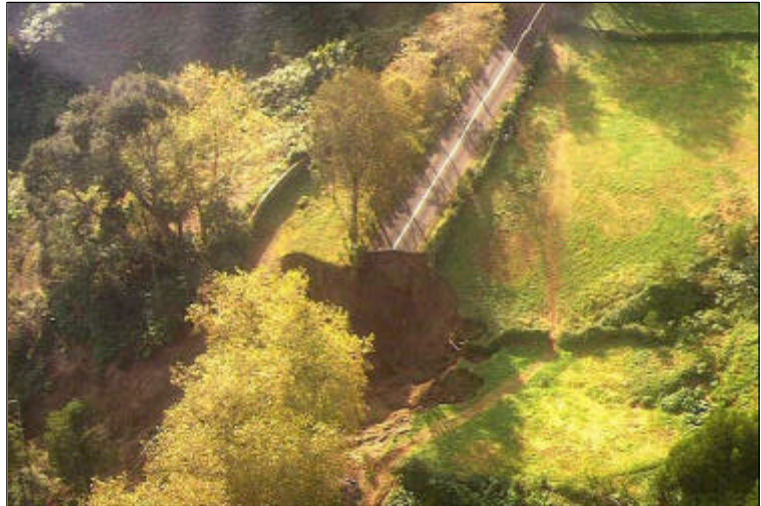
**Figure 4.5** Road cut off by the collapse of the edge of a streamline at Furnas Volcano, during the 1997 event

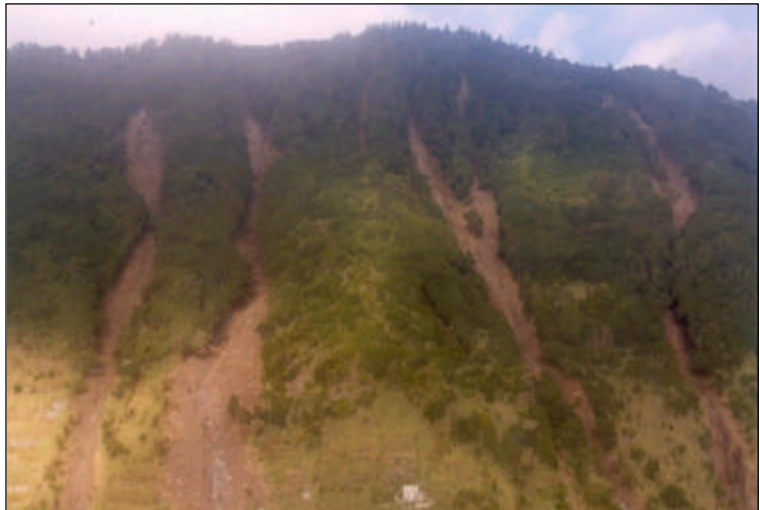
**Figure 4.6** Head of debris flows and mudflows caused by the intense precipitation occurred in the dawn of 31 October 97, on a hillslope in the Povoação district

Most of the landslides were essentially very fluid debris flows, consisting of a mixture of water, pumice and ash. Trees with their root systems, trunks and branches were included in most deposits (Valadão, 2002; Valadão *et al.*, 2002). Depending on the source, some debris flows transported large blocks of lava, normally less than 1 m across. The predominance of water conferred the debris flows low viscosity, enabling them to gain high speed.

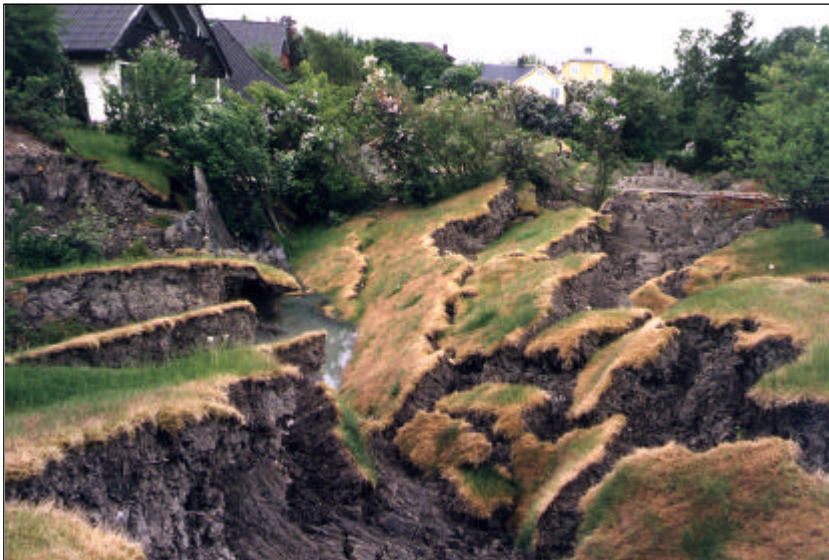
**Figure 5.3** Partial view of the head of the 23 May 1997 landslide. A tilted house can be seen near the upper left corner

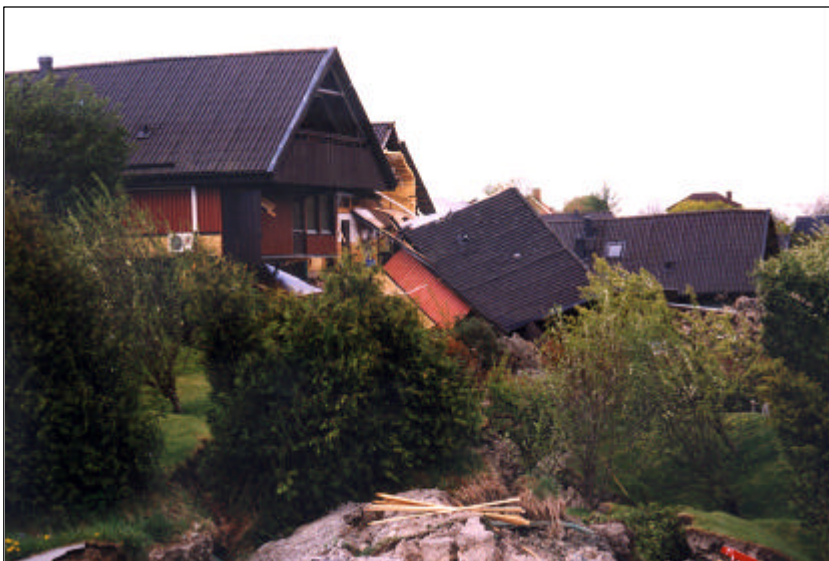
**Figure 5.4** House destroyed by the 23 May 1997 landslide

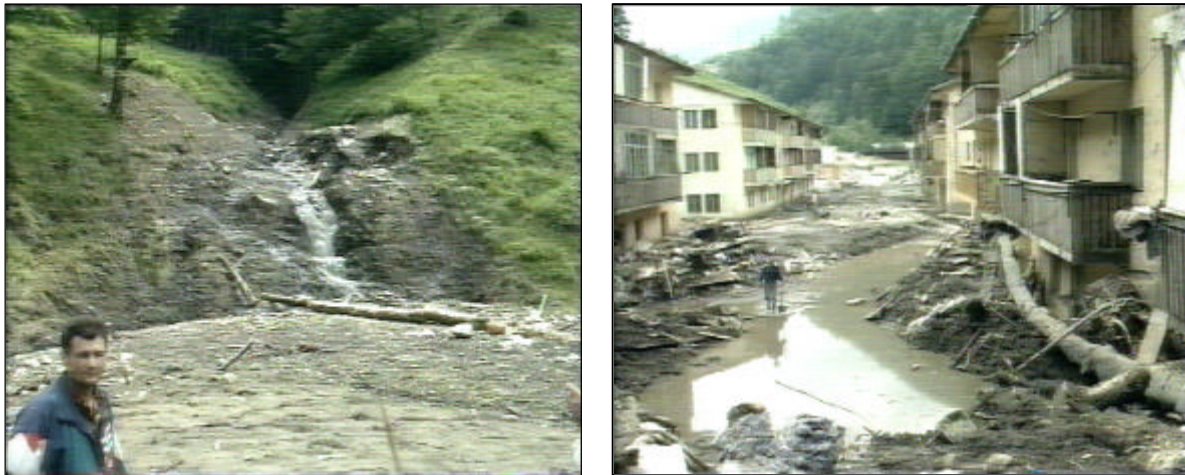
Figure 6.3 Left: spring contributing to the mudflow triggering. Right: debris carried by the mudflow at Tomeasa

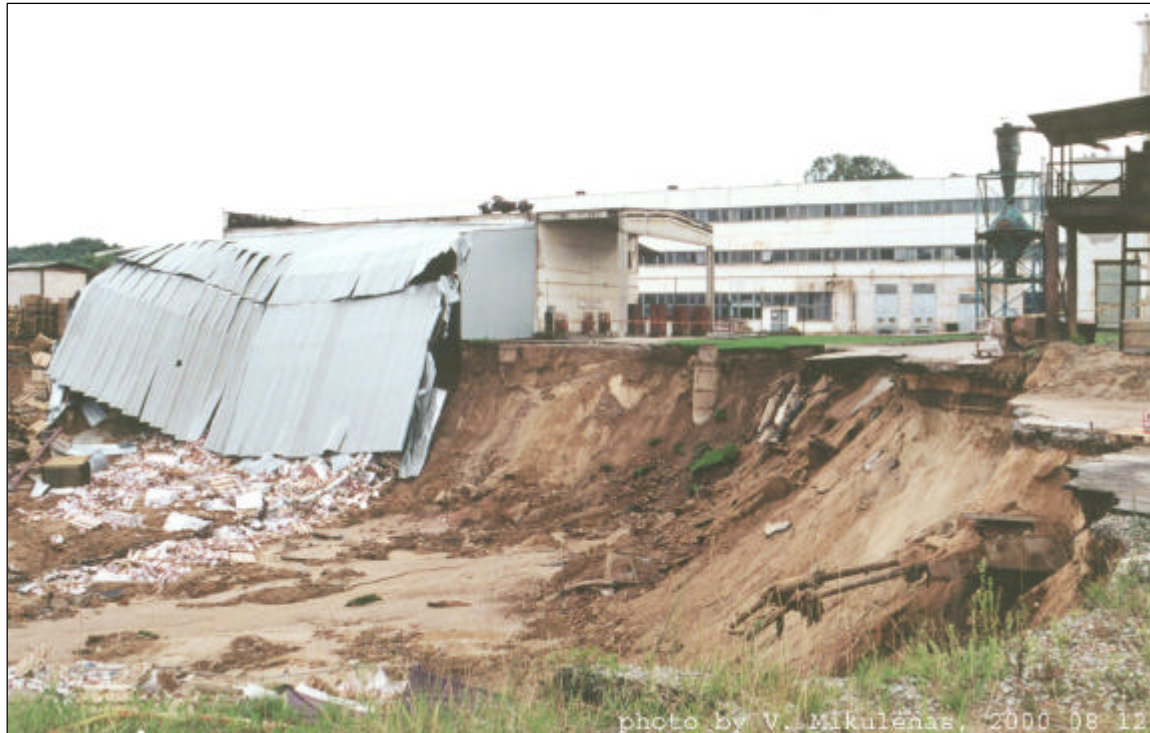
**Figure 7.1** Landslide head scarp and destroyed storehouses

On 11 August 2000 at 22.25 hrs, the guard of the Joint Stock plant "Dvarcioniu keramika", which produces wall and floor ceramic tiles, noticed that two storehouses for keeping the production of the company had crashed and fell down the precipice, together with about 80,000 m<sup>3</sup> of soil, to the valley of Dvarcios creek. The landslide affected an area of 7,200 m<sup>2</sup>, 2,150 m<sup>2</sup> of which belonged to the plant site, covered with asphalt and including the rain sewerage. The landslide destroyed two storehouses: an underground oil collection system (738 m<sup>2</sup> and 432 m<sup>2</sup>), a 132 m long section of the rain sewerage system, a 135 m long technical water underground system, a 220 m long underground heating route with a concrete chute, the plant fence and an artificial slope. It also blocked the Dvarcios creek and valley by a dam of debris and mud 3-4 m high. Also, this landslide destroyed 110,874 m<sup>2</sup> of the tiles produced by the company (Fig. 7.1 and 7.2).

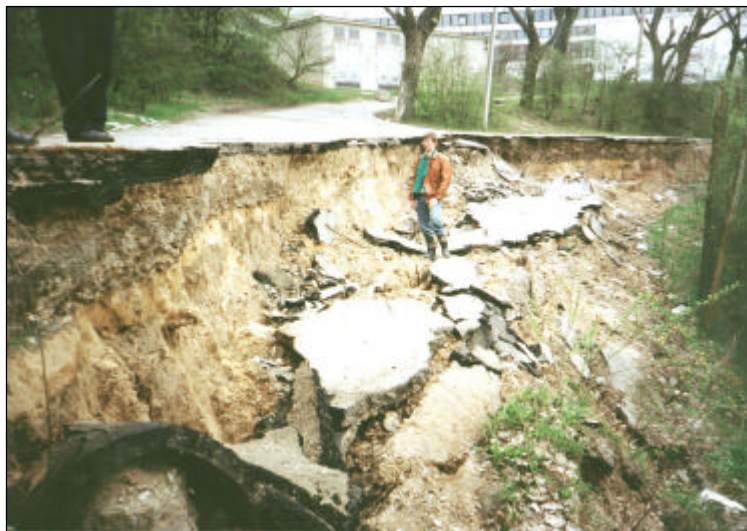
**Figure 7.2** Partial view of the landslide head scarp

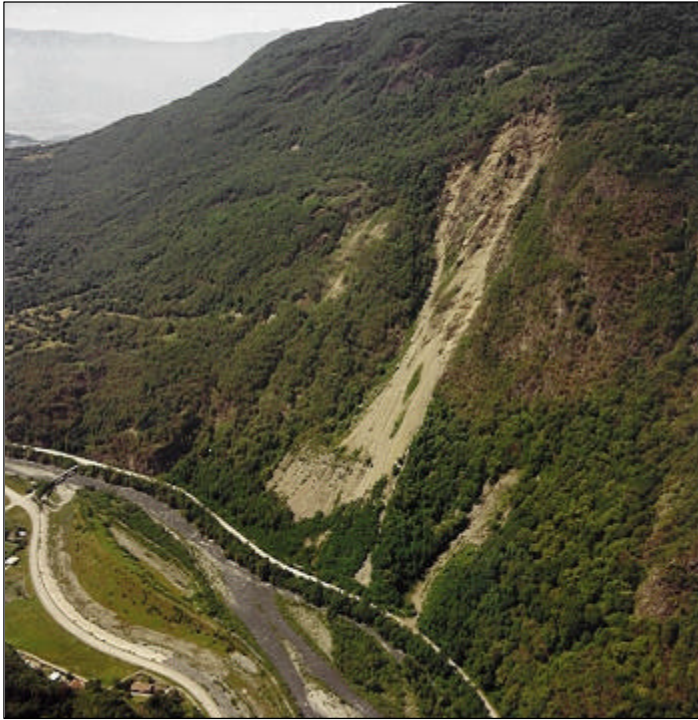
**Figure 8.2** View of the central and lower part of the unstable slope at Les Ruines de Séchilienne. The lighter area corresponds to shallow movements (topples and rockfalls). The Romanche River and the diverted road are apparent at the bottom

The unstable slope has an elevation difference of 800 m and an inclination of 45° (Fig. 8.2). In this area the rock formations are split up by major fractures, provoking numerous internal displacements evidenced by very marked depressions in the morphology of the slope (Fig. 8.3). If an image had to be given, we could say that there are many rock blocks of some tons to some hundred tons floating in a kind of detritic moraine generated by the grinding of the rocks due to tectonic faulting. The consistency of this "gange" is thus directly related to the water content of the ground. There is a very significant water flow and a rise of the pore water pressures. Therefore gravitational movements slowly develop.

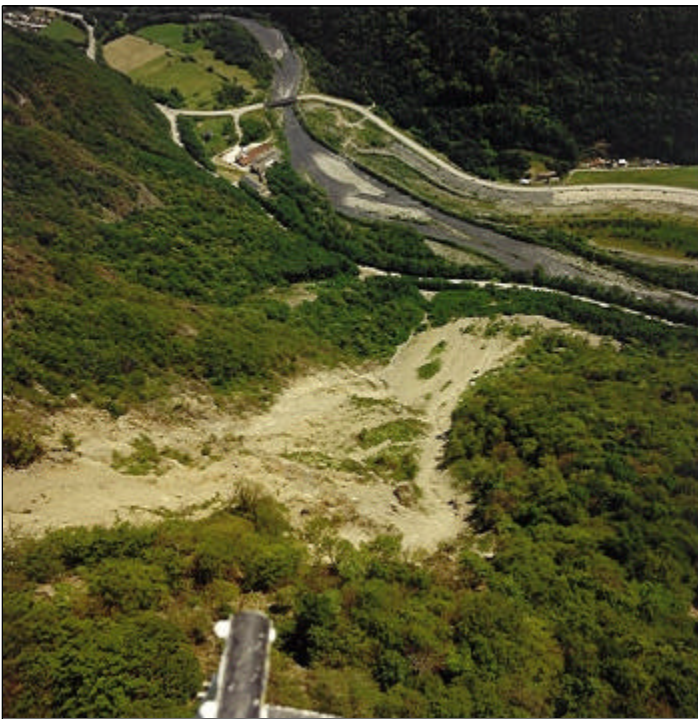
**Figure 8.3** Closer view of the shallow movements shown in the previous figure. The irregular morphology of the slope reflects however deeper deformation in the rock massif

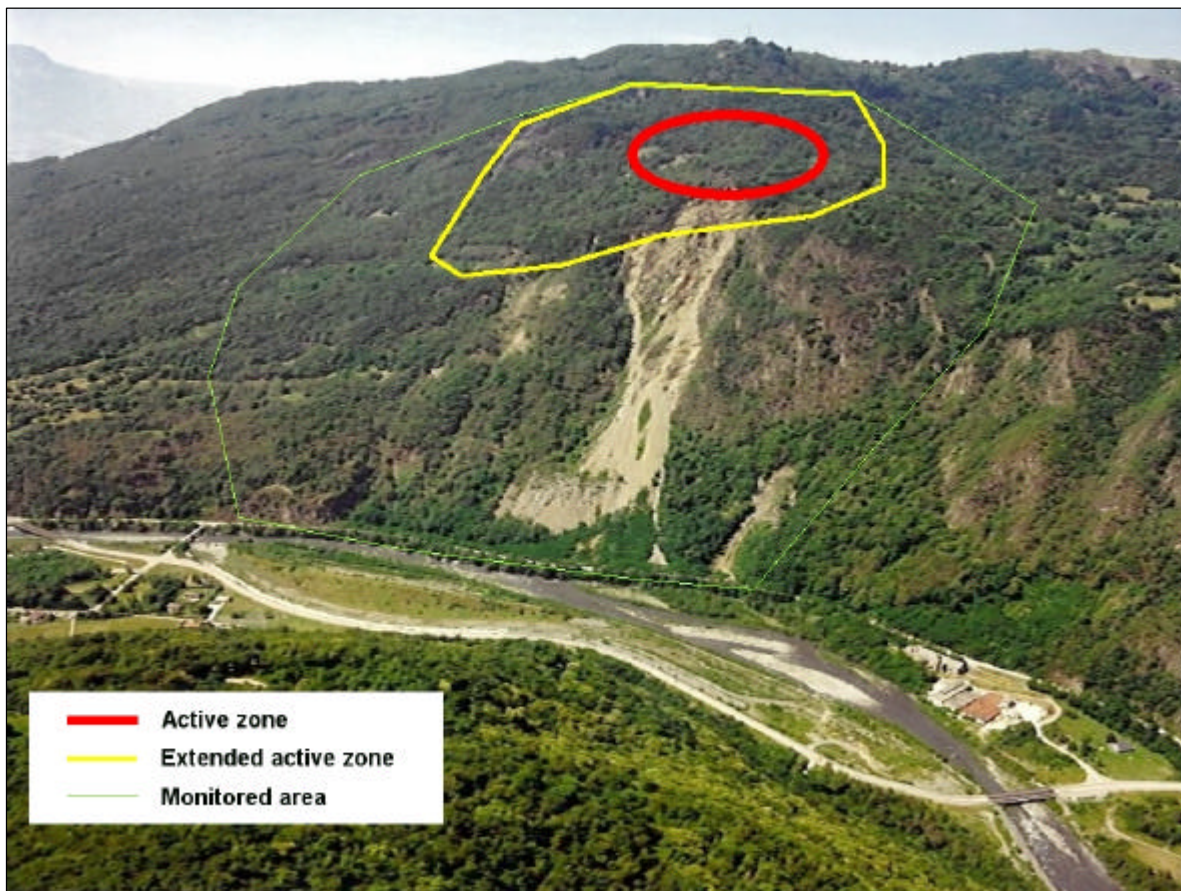
**Figure 8.4** Zones considered in future catastrophic mass failure scenarios at Les Ruines de Séchilienne

- The most obvious scenario for the very short and short term is the continuation of what was observed along centuries on the site of Les Ruines de Séchilienne, namely rock mass failures by toppling, not exceeding a volume of a few hundred to a few thousand m<sup>3</sup>. The blocks would follow the corridor of the "ruins", reaching the old national road in the valley. The current movements show that such rockfalls are likely in the very short term.
- The collapse of the whole active zone, including its possible extension to the southwest, while the extension to the southeast is also a foreseeable short-term scenario (Fig. 8.4). There are no elements that enable to clearly identify a surface of rupture, but the continuation of the flexion and compression movements can lead to a massive rock avalanche. Its volume could then be estimated to be between 2.2 and 2.6 million m<sup>3</sup>.

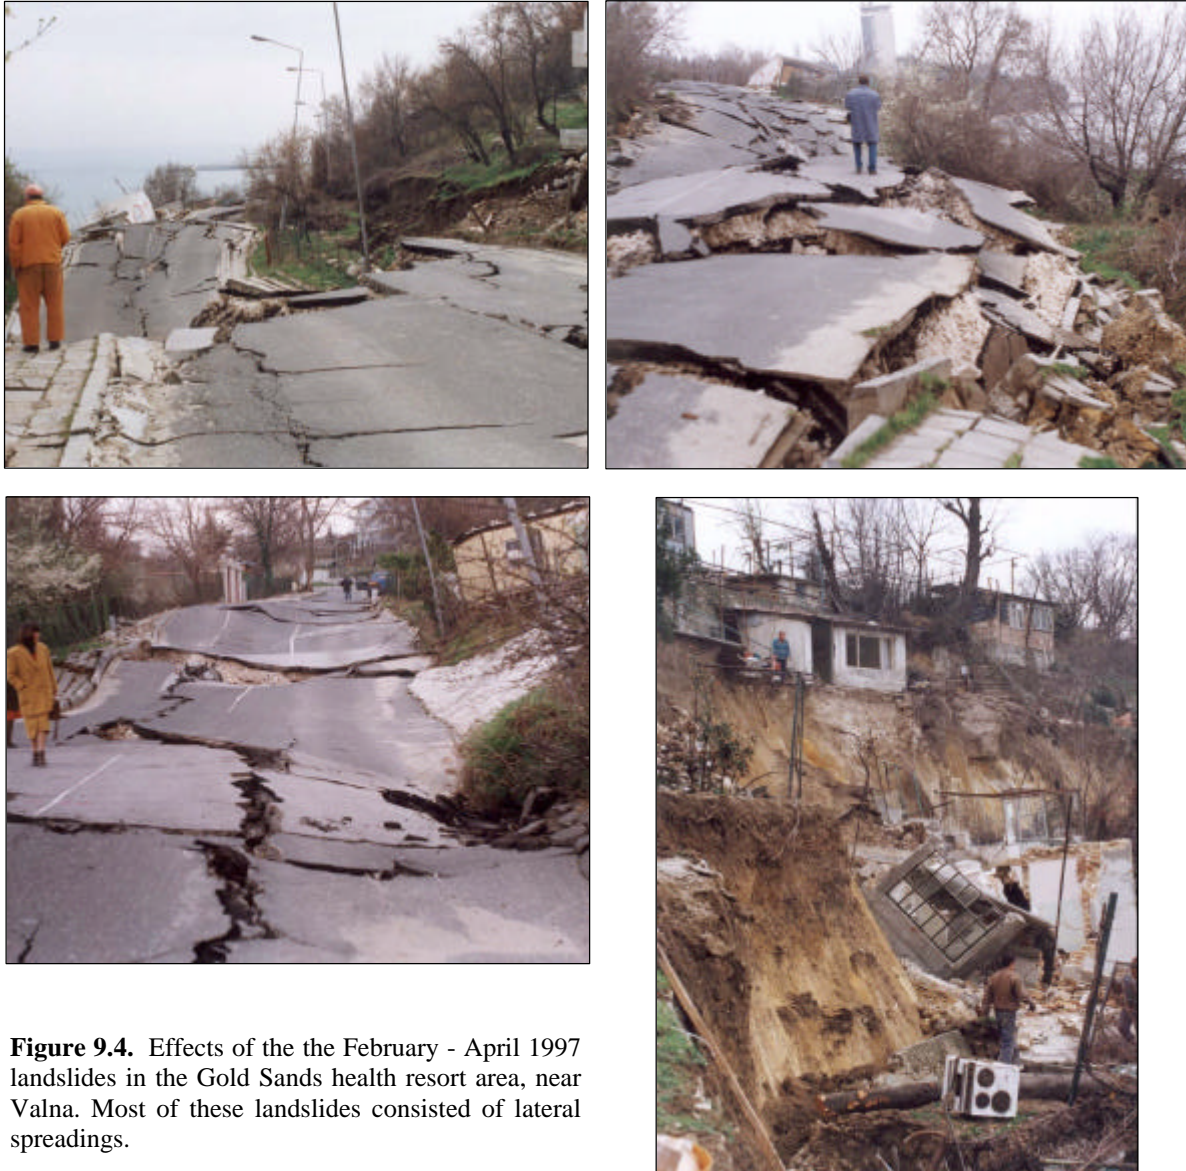
**Figure 9.4.** Effects of the the February - April 1997 landslides in the Gold Sands health resort area, near Valna. Most of these landslides consisted of lateral spreadings.
